2023 Aquatic Invasive Species Sentinel Survey II (Diver Survey & Lakewide Search)

Cedar Lake (#01-0209)
Aitkin & Crow Wing County, MN

Diver Survey: August 5, 2023
Lakewide Search: September 13, 2023

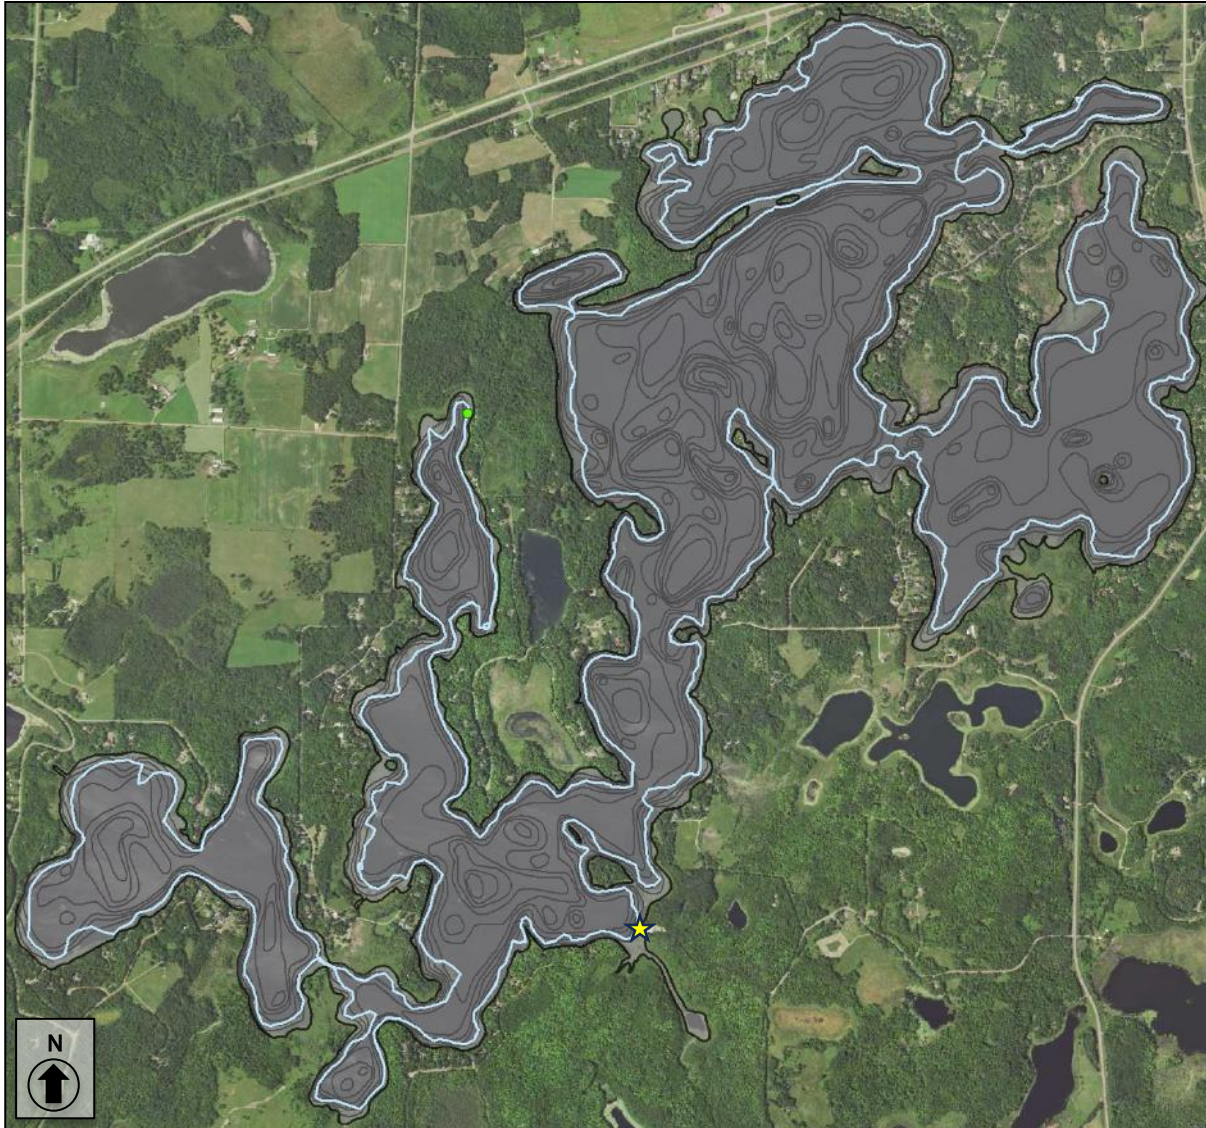
Cedar Lake (#01-0209) AIS Sentinel Survey / Diver Survey

We did not find any new aquatic invasive species during the late-summer boat survey or diver survey. However, we did find two curlyleaf pondweed plants growing at one of the locations where we found CLP earlier in the summer (near the beaver dam at the north end of the long southwestern bay). These CLP plants appeared to be from late summer sprouting of buried turions. No management is necessary this fall, but this location should be monitored in the spring of 2024 to determine the best management strategy (manual removal or herbicide). We did not find any CLP in the northern portion of the lake.

- Surveied Path (27 miles)

Curlyleaf Pondweed Density

- 1
- 2
- 3

★ Diver Survey Site

Surveyed: Aug 5 & Sep 13, 2023
Methods: Visual, Rake, Sonar, Diver
Surveyor: JA Johnson

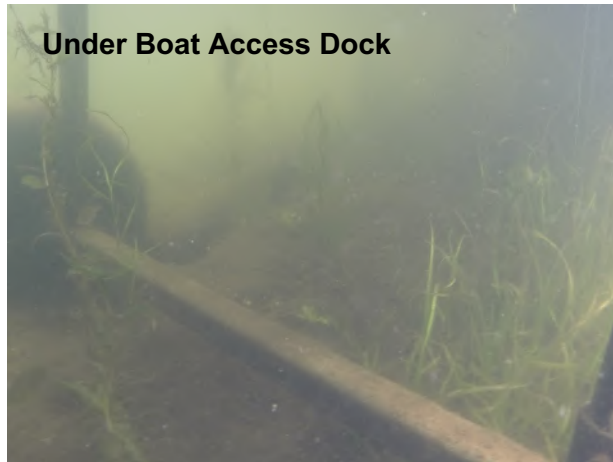
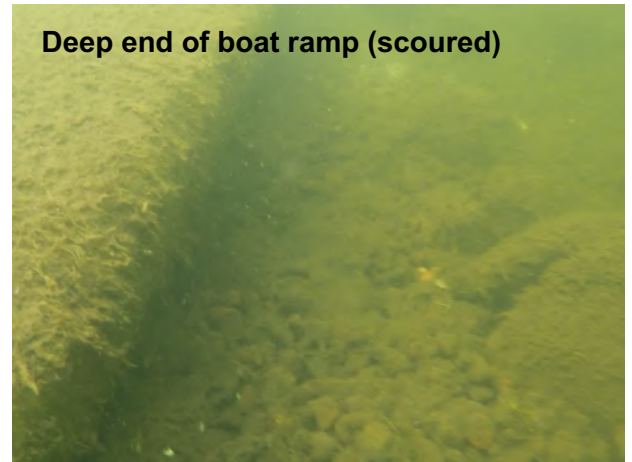
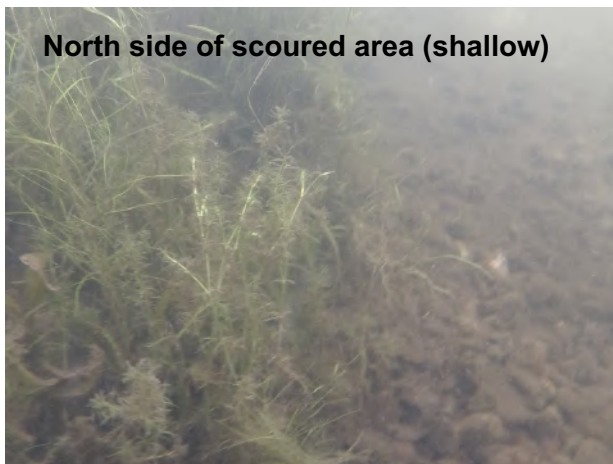
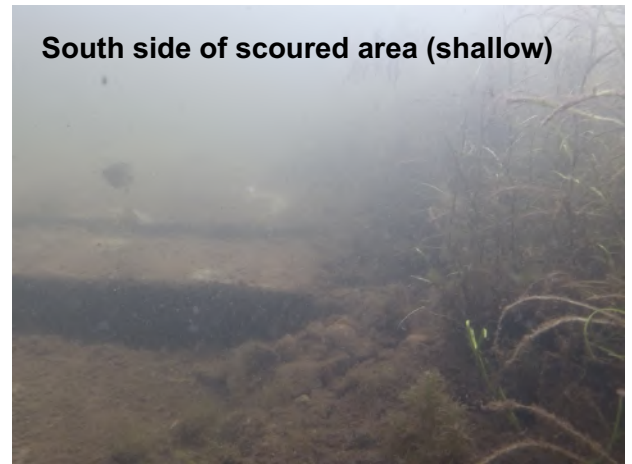
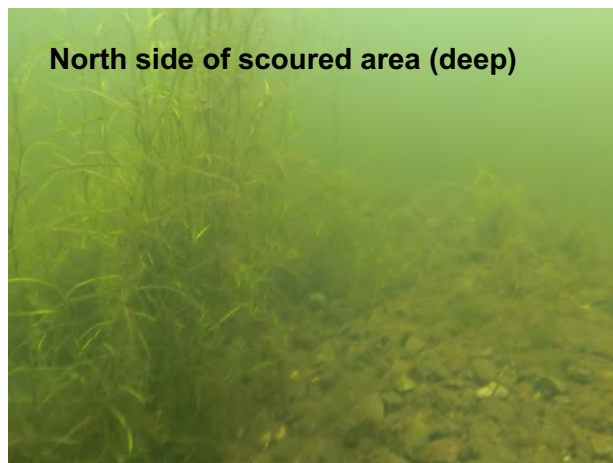
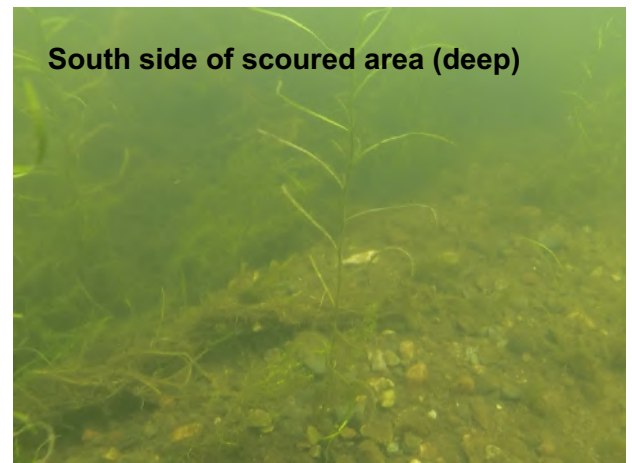
Diver Survey Photos (Surveyed: August 5, 2023)

On August 5, 2023, we conducted an intensive, systematic diver search around the public boat access site. This search included inspections of the boat ramp, dock, prop-scoured area, and the area of dense plants immediately surrounding the boat ramp.
